## MAP1251C Over Boost Clamping Device

### For Toyota Engines or any Other Engines Need to Clamp Over Boost Condition

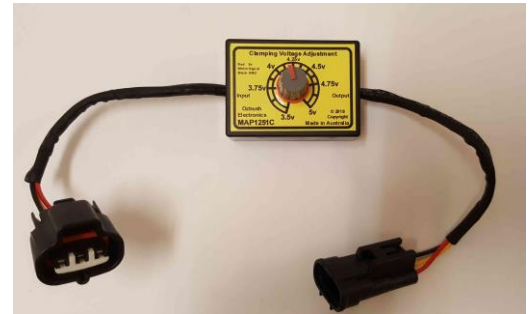
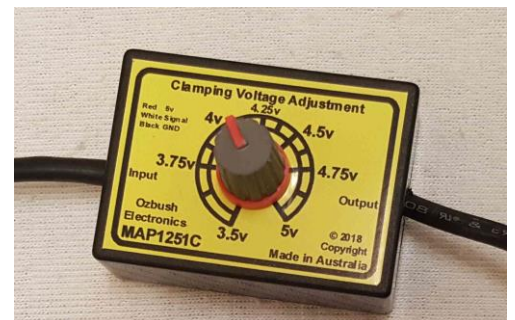
**Installation:** The unit is completely waterproof (Silicon Potted). Please insert the unit between the MAP sensor and car computer. **Please fix the unit body with suitable cable ties so it won't rattle around and end up broken wires.**

We have two types of this device, one is with specific engine MAP connectors so you can install easily by just plug in. Or a version with just flying wires for you to connect manually. Later one is cheaper due to not using auto connectors.
