## MAP1251C Over Boost Clamping Device

### For Toyota Engines or any Other Engines Need to Clamp Over Boost Condition

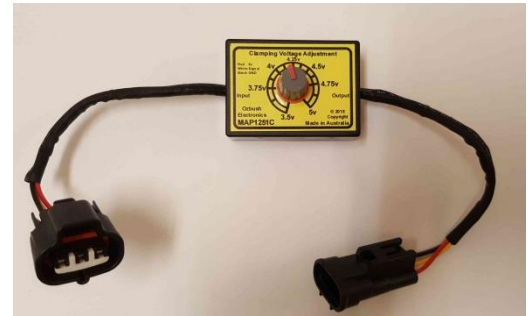
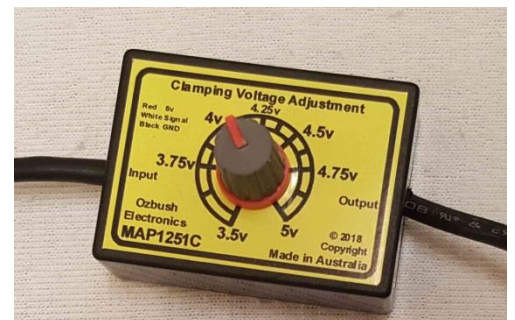
**Installation:** The unit is completely waterproof (Silicon Potted). Please insert the unit between the MAP sensor and car computer. **Please fix the unit body with suitable cable ties so it won't rattle around and end up broken wires.** If you worried about deep water fording, you can use silicon to seal the gap under the potentiometer knob only after completing the testing.

We have two types of this device, one is with specific engine MAP connectors so you can install easily by just plug in. Or a version with just flying wires for you to connect manually. Later one is cheaper due to not using auto connectors.

After you checked out and all is okay and no faulty parts? Only then try out our device which can be solved by clamping MAP sensor output using our MAP1251C device. The device is inserted where the MAP sensor is and takes 1 minute to install. The MAP1251C has a potentiometer for adjustment to stop MAP sensor output climbing, which causes the over boost error code. The device will not cause barometric sensor failure by having delay circuit.

The device will NOT reduce the MAP output voltage in anyway, but only clamp or stop MAP output voltage rising at set point by potentiometer. It can be set between from 3.5v to 5v. Most of over boost error will trip around from 3.9 to 4.3v, but I found every engine was different so you need to experiment on your engine. You can start from 4.75v and bring potentiometer down a little by little towards 3.5v until you get no more error code.
