Ozbush Electronics

Manual Mapper® instruction manual

Model: OBM-2 for Toyota 1KD-FTV Engines

Installation Procedure for OBM-2

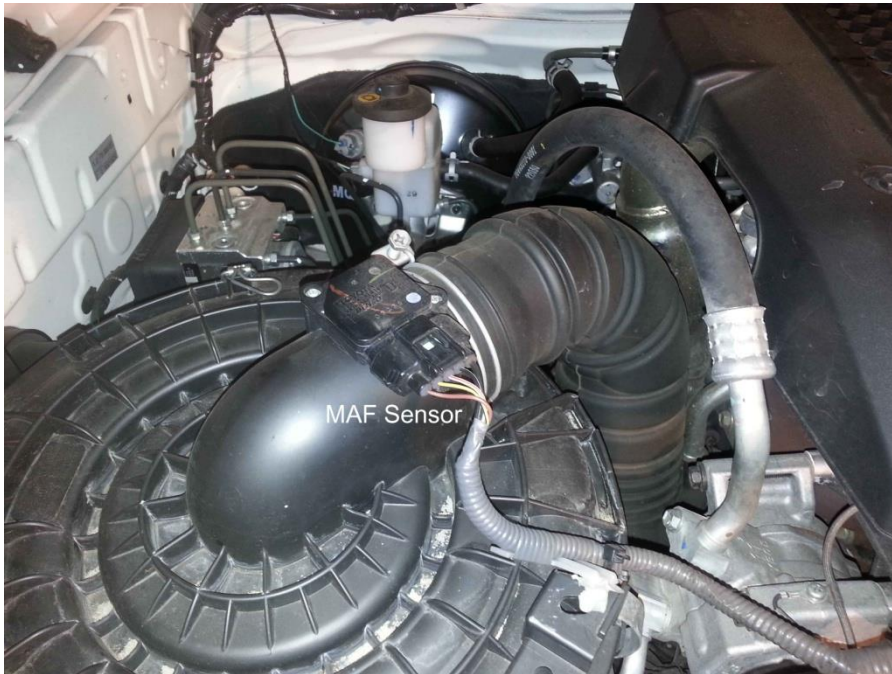
2... Locate MAF sensor. It is located on top of the air filter box.

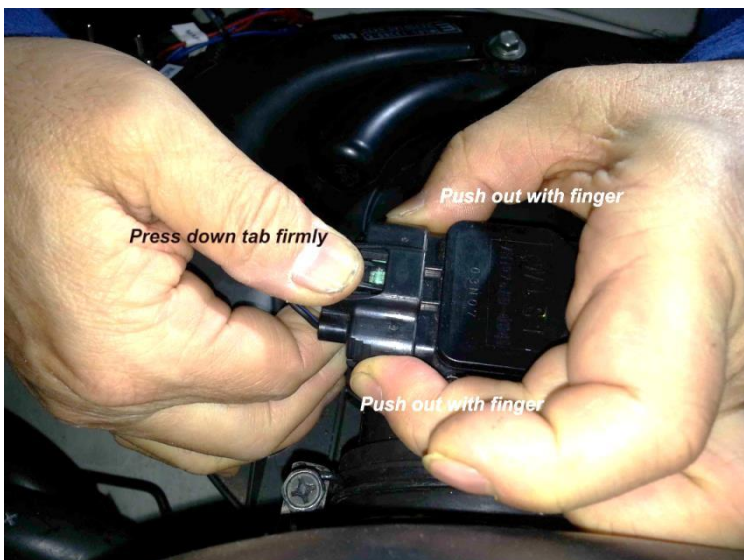
3... Disconnect the MAF sensor plug from its body. Press down the plastic locking tab on the plug, then pull out by holding the plug (Do Not pull by wire).

Please note that MAF sensor body is made out of plastic and very fragile and easy to crack. Be careful when you are pulling the connector out.

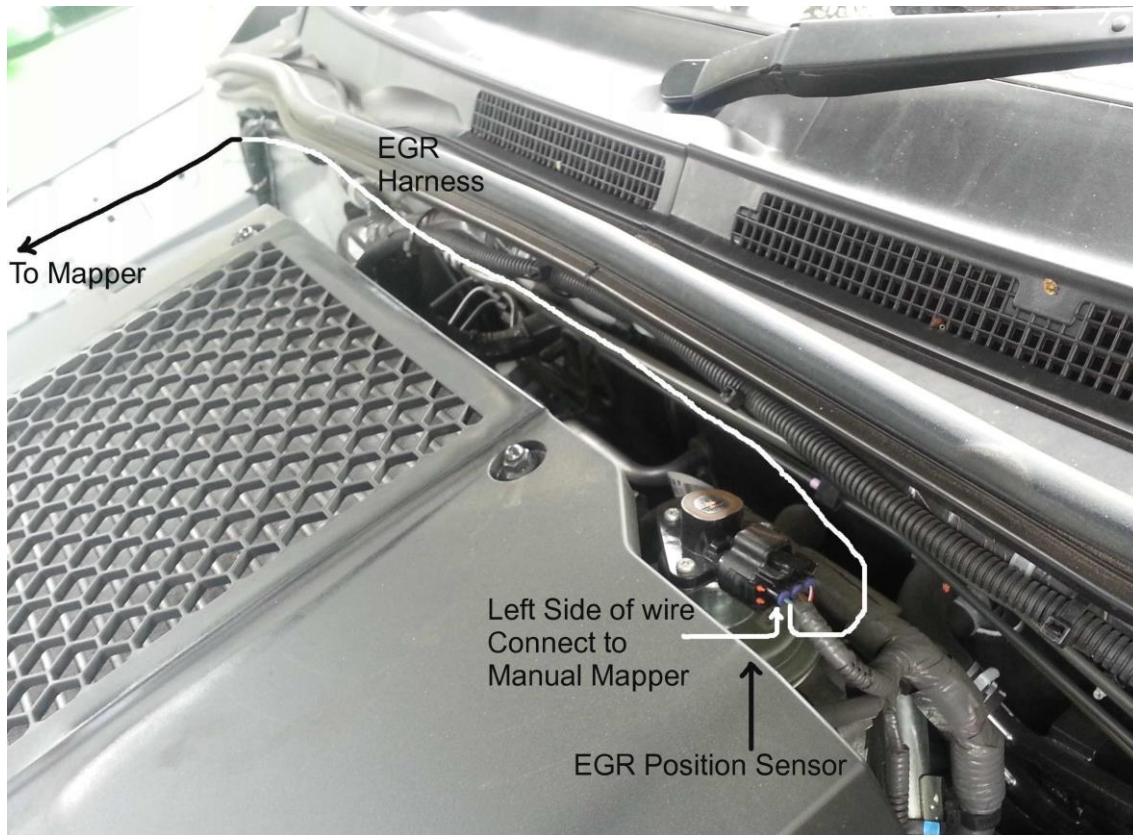
7... Connect EGR harness from EGR position sensor to Green wire terminal in Manual Mapper with a suitable wire. We recommend soldering it directly to back of the EGR sensor connector.

Wiring information for connecting EGR Position sensor signal to Manual Mapper.

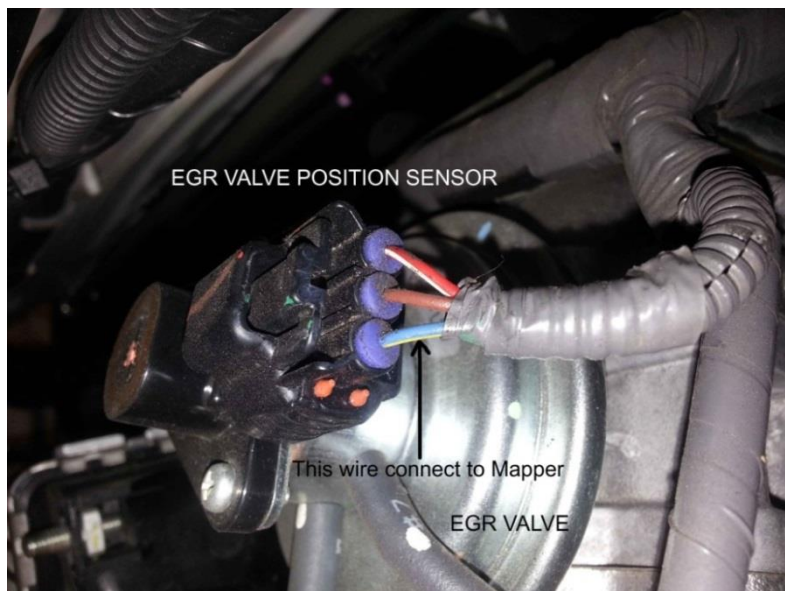
Picture of EGR Valve Position Sensor.

Please connect left side of wire (EGR signal) regardless of colour of wire. Please do not use wire splicer as it cannot make reliable connection and will make trouble near future by corrosion.

For Old Hilux up to 2006 has slightly different EGR connector which has a notch in the middle, in this case the EGR signal is middle wire. (3 pins: 5V Ref Volt, EGR signal and Ground)

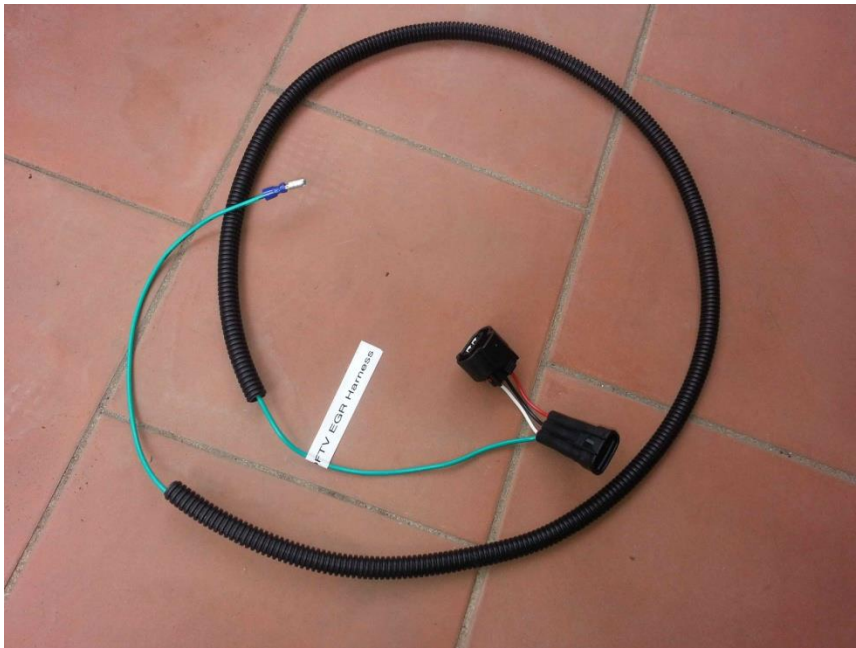
You may just purchase plug and play EGR harness from us if you don't have the time or resources.

Photo of plug and play EGR Harness. Nothing to cut and solder just plug it in.

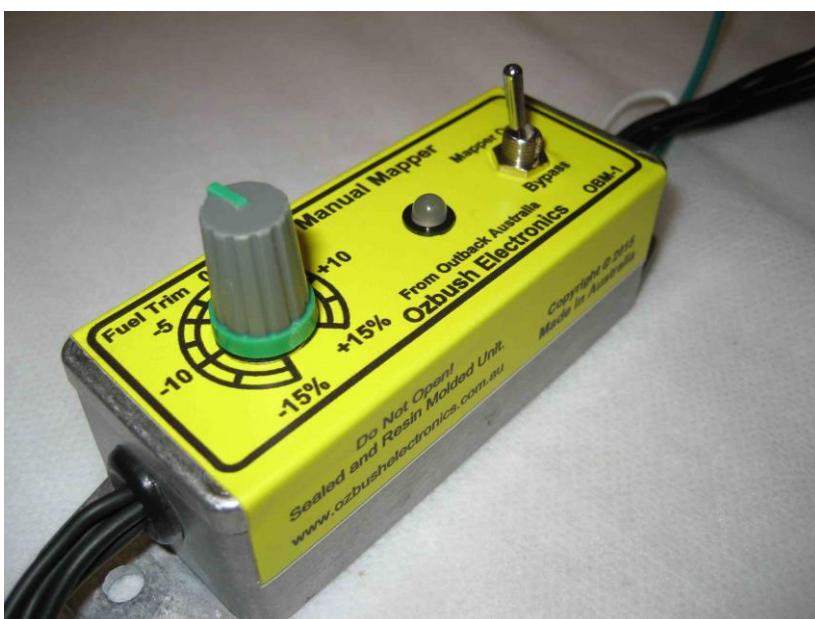
You can try the fuel trim setting,

Set to -5% you will find car will go very quietly and smoothly with good fuel economy.

The Car can be very sluggish if set too lean like -15% but it will give you incredible fuel economy.

Set to +5% you will feel the car has more power while it will still give you better fuel economy than without Manual Mapper.

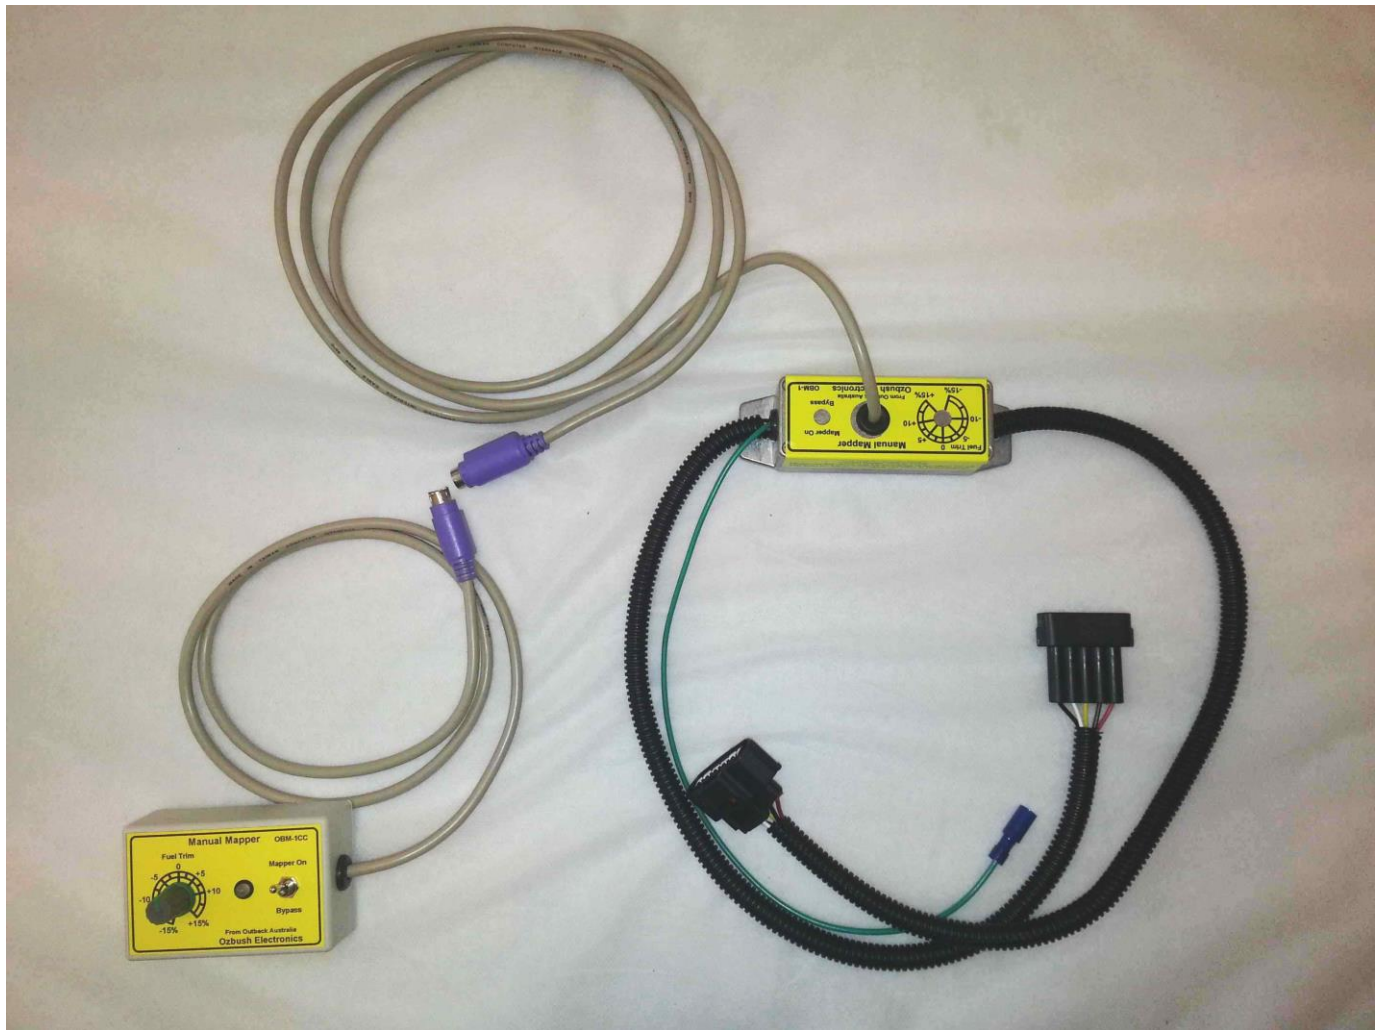
For **OBM-2CC**, In cabin control Manual Mapper:

Please use Velcro strap provided to mount inside of the cabin where you can see and reach easily to control fuel trim.

The cable connecting between in cabin module and Manual Mapper under the bonnet is a very fragile, thin copper wires, therefore, not to be stretched too hard when you install.
